ADDENDUM NUMBER 1**PROJECT:** University of Colorado, Colorado Springs
Replace Roof, Columbine Hall
Project Number: 2019-106M22**DATE:** March 22, 2023**OWNER:** University of Colorado, Colorado Springs
1420 Austin Bluffs Parkway
Colorado Springs, Colorado 80918

MEMORANDUM

PROJECT: **UCCS Columbine Hall, Replace Roof** DATE OF OBSERVATION: November 4, 2022
Project No.: 2019-106M22 ISSUED BY: Ben Kubczak

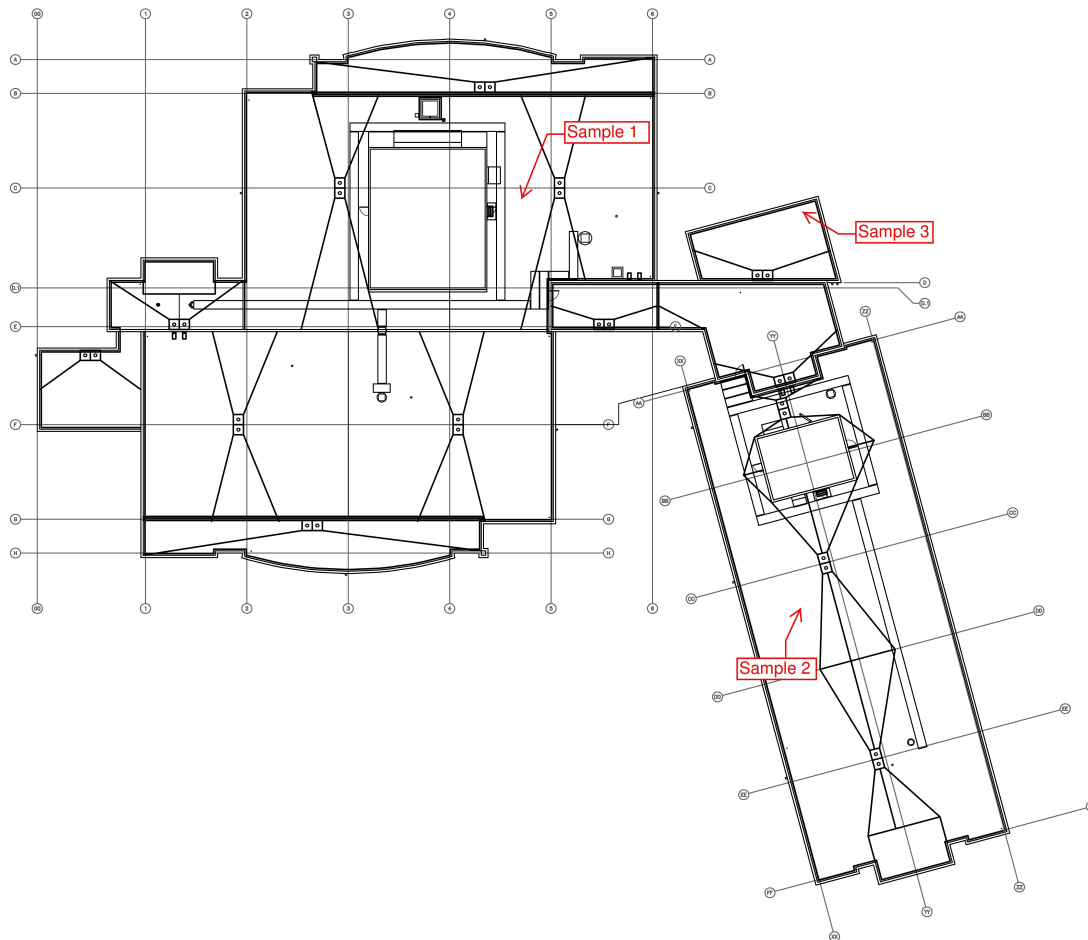
Weathercraft Roofing was hired to extract the samples and to patch & repair sample locations afterwards. Extracted samples were rectangular cuts 4"X4" minimum in size and stopped at top of the structural roof deck. Samples were taken from three (3) locations in total as indicated on the below roof plan (not to scale):

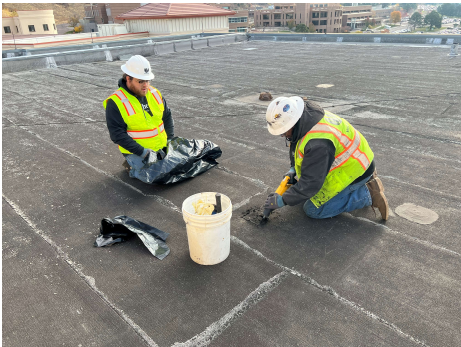
Above: Cutting of Test Sample 1

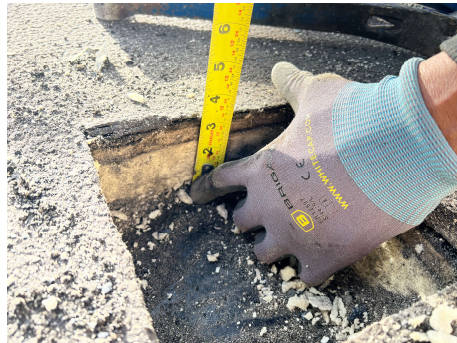
- 1/4" thick asphaltic cap sheet and base plies set in mopped asphalt
- 1/2" thick fiber protection board
- 2-1/2" thick glass mat-faced rigid polyisocyanurate insulation set in adhesive over concrete deck

- 1.) No evidence of water damage/infiltration in roof construction, however Owner had replaced water-damaged areas of the roof earlier in the year. Sample was collected from an area of original roof construction and not a more recent repair patch.
- 2.) 1996 Construction Drawings (sheet A5.01) calls out "Built-up roof" over "Rigid Insulation". No material types or thicknesses are listed.
- 3.) Estimated existing R-Value at this location:
Asphalt roofing w/ 3/4" Protection board: **R-1.5**
Polyiso insulation per inch: R-6 X 2.5" = **R-15***
Total R-Value: **R-16.5**
- 4.) Base plies seem thinner in this sample and appears that there may only be 2 plies present below cap sheet.

Above: Test Sample 1 Cross-section in field

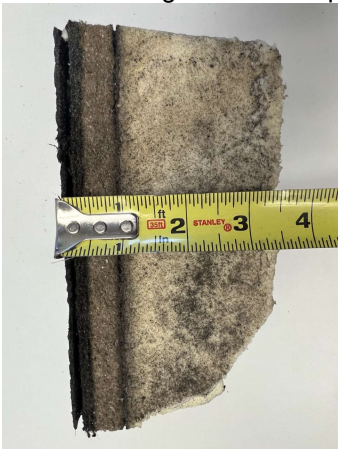
Above: Test Sample 1 Cross-section

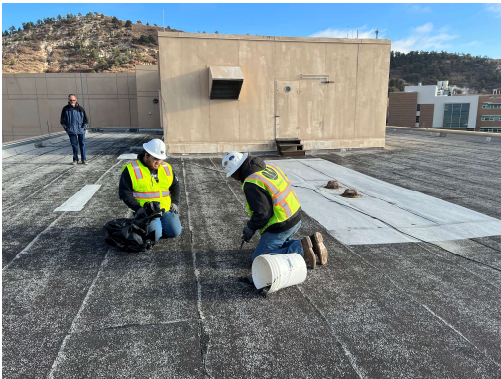
Above: Cutting of Test Sample 2

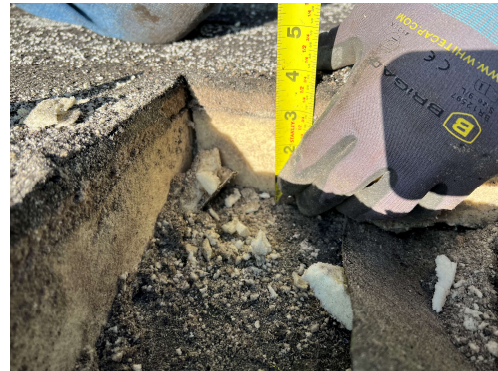
- 1.) No evidence of water damage/infiltration in roof construction, however Owner had replaced water-damaged areas of the roof earlier in the year. Sample was collected from an area of original roof construction and not a more recent repair patch.
- 2.) 1996 Construction Drawings (sheet A5.01) calls out “*Built-up roof*” over “*Rigid Insulation*”. No material types or thicknesses are listed.
- 3.) Estimated existing R-Value at this location:
Asphalt roofing w/ 3/4” Protection board: **R-1.5**
Polyiso insulation per inch: R-6 X 2.5” = **R-15***
Total R-Value: **R-16.5**
- 4.) Three base plies visible

Above: Test Sample 2 Cross-section in field

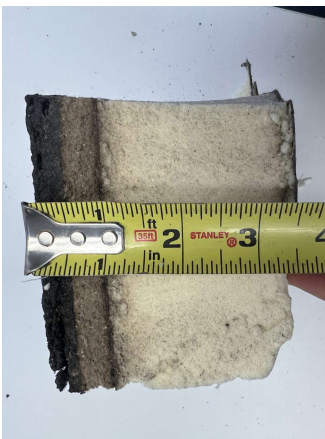
Above: Test Sample 2 Cross-section

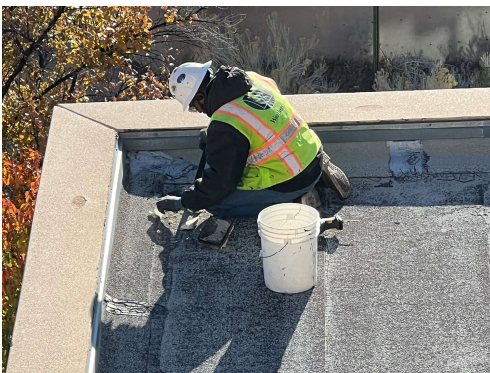
Above: Cutting of Test Sample 3

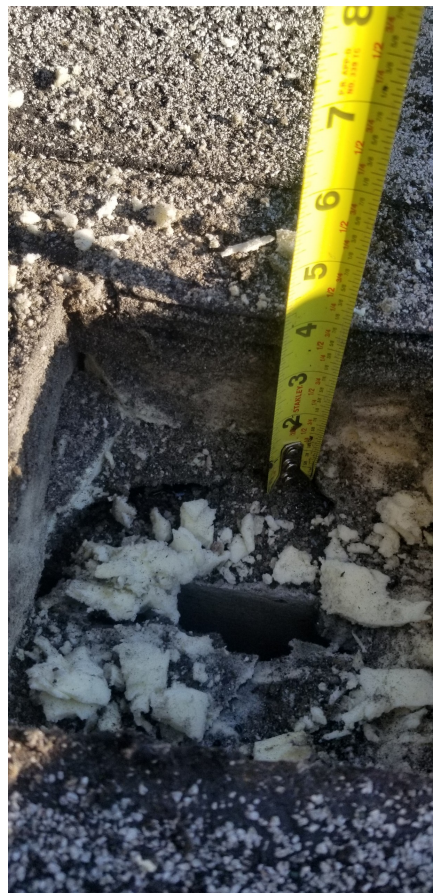
- 1.) No evidence of water damage/infiltration in roof construction
- 2.) 1996 Construction Drawings (sheet A5.01) calls out "Built-up roof" over "Rigid Insulation". No material types or thicknesses are listed.
- 3.) Estimated existing R-Value at this location:
Asphalt roofing w/ 3/4" Protection board: **R-1.5**
Polyiso insulation per inch: R-6 X 2.5" = R-15
Total R-Value: **R-16.5**
- 4.) This sample was taken approximately 12" from the northern edge of roof and is assumed to be the lowest existing "parapet" condition.

Above: Test Sample 3 Cross-section in field

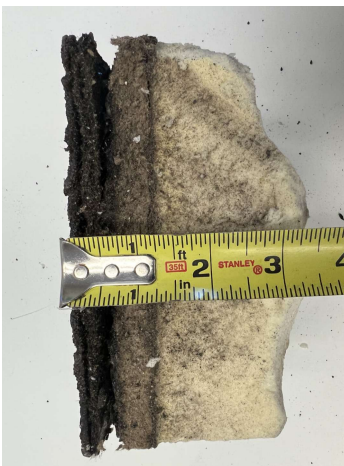
Above: Test Sample 3 Cross-section
